Manhole Inspection Summary

Manhole # S19GG2016MH

Insp Date: **4/24/07 11:18 AM**

Location Address: **FALLS RD**

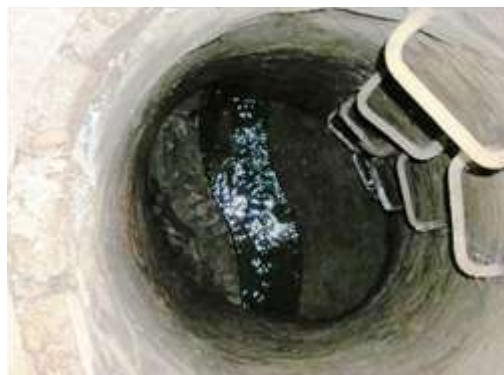
Top View

Channel debris. Bench debris.

Evidence of surcharge

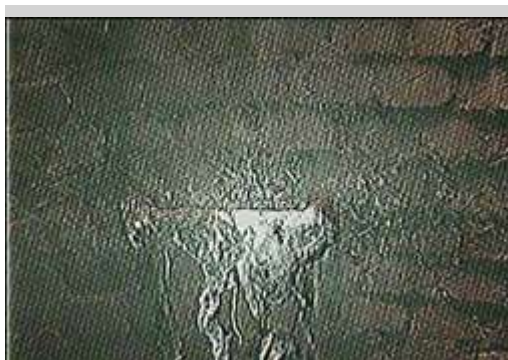
Defect

Frame leaks. Adjustment deterioration, loose brick, cracks and infiltration. Corbel infiltration.

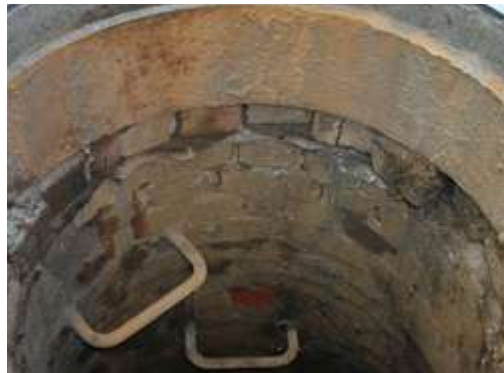
Defect

Frame leaks. Frame offset. Adjustment deterioration, loose brick and infiltration. Corbel and Barrel infiltration - other side.

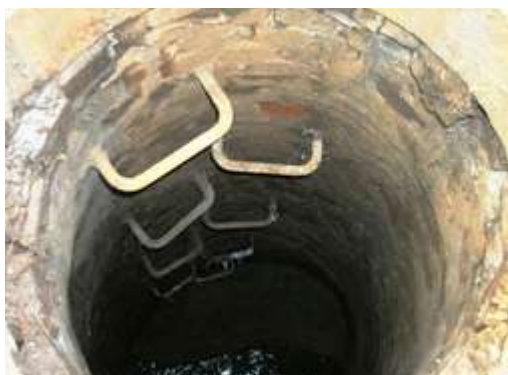
Defect

Frame leaks. Frame offset. Adjustment deterioration, loose brick and infiltration. Corbel and Barrel infiltration.

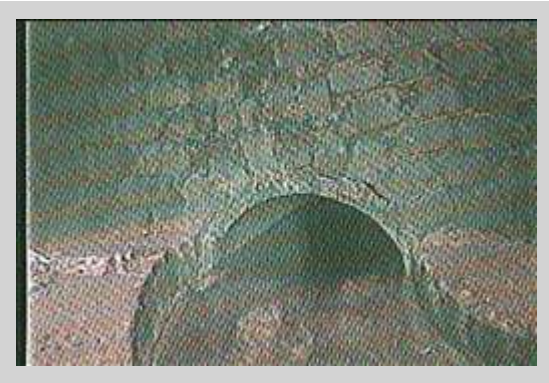
15 in. Circular Gravity Sewer Pipe Out @ 12 O'Clock

Comments **The O12 pipe picture shows Barrel deterioration.**

Barrel deterioration and infiltration. Channel deterioration.

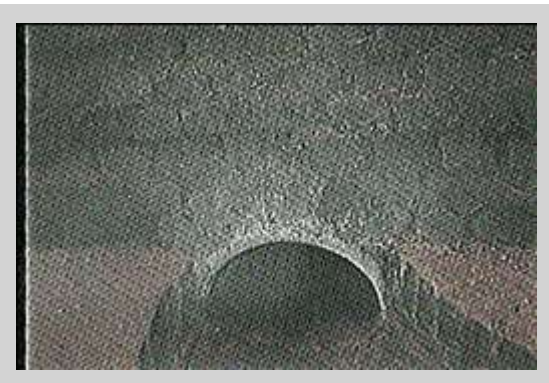
12 in. Circular Gravity Sewer Pipe In @ 5 O'Clock

Barrel deterioration and infiltration. Channel deterioration.
